# **Mobile Intel<sup>®</sup> Celeron<sup>®</sup> Processor on .13 Micron Process in Micro-FCPGA Package Specification Update**

Release Date: January 2003

Order Number: 251309-007

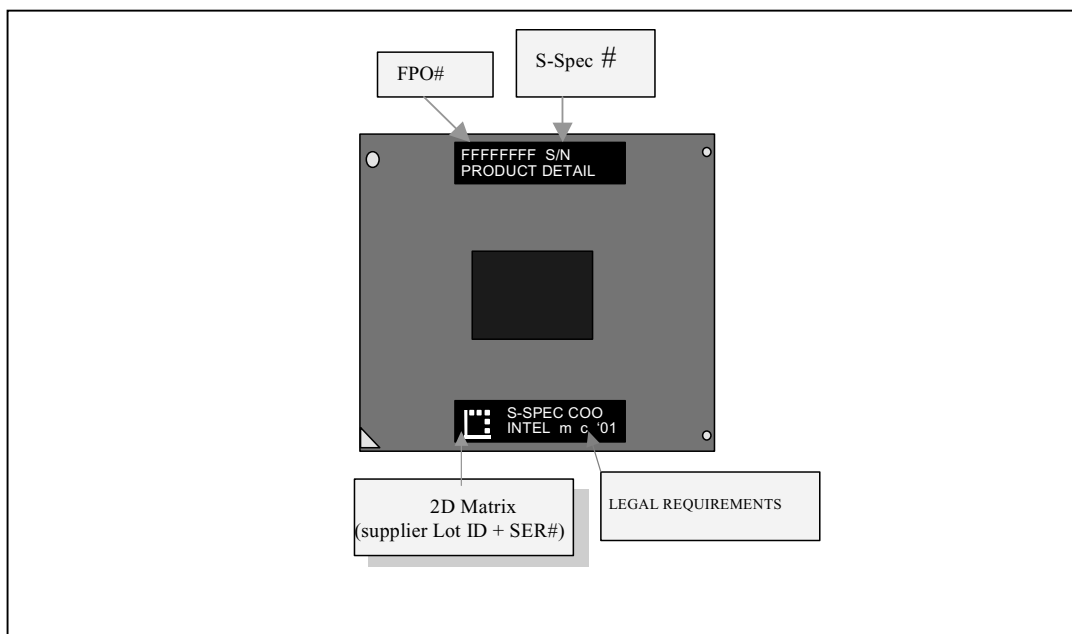
### *Mobile Intel® Celeron® Processor on .13 Micron Process (Micro-FCPGA) Markings*
